101
C.C.J.J. Commission of Criminal & Juvenile
Justice

Dimension/S F 4 Rehabilitation Zone
Original Use Land
Commissioner

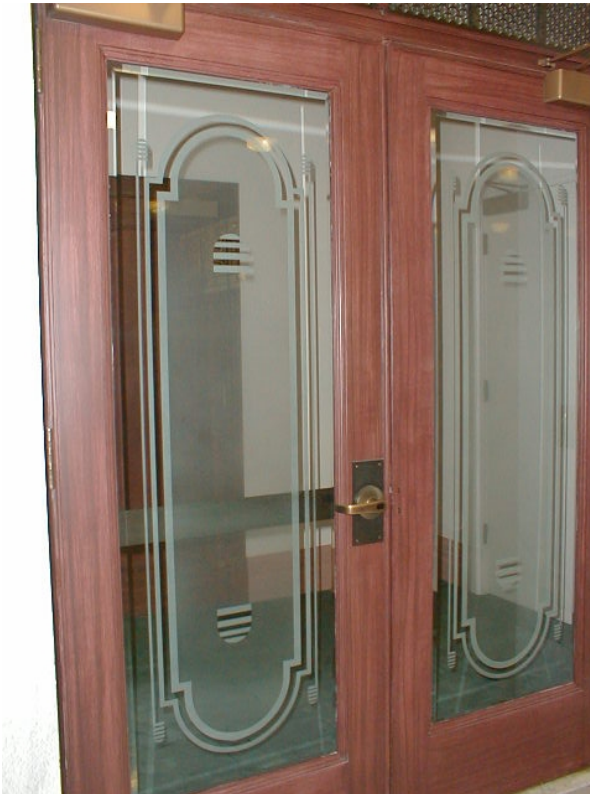
Element	Description	Historical Significance	Notes
B-6	Plaster base, painted	Contributory Qty:	Check for accuracy on description
CL-06	Sheetrock ceiling, painted	Non Contributory Qty:	
CL-08	Acoustical ceiling, suspended T-bar frame	Non Contributory Qty:	
D-11	Metal wood-grained panel door with matching casing. Plain louver transom	Contributory Qty:	
F-11	Carpeted floor, on pad	Contributory Qty:	Has a quilted appearance - field carpet
L-81	Parabolic	Non Contributory Qty:	
W-8	Sheetrock wall, painted and smooth	Contributory Qty:	
D-06	Metal wood grained panel door with frosted glass panels. Casing is decorative wood or metal wood grained.	Significant Qty:	Double door, with Marble Threshold - Main Entry
D-25	Wood panel door with decorative wood casing	Non Contributory Qty:	To computer room which joins to the Attorney Generals office
D-23	Wood slab door with decorative wood casing	Contributory Qty:	Door to Committee room 225 - Single

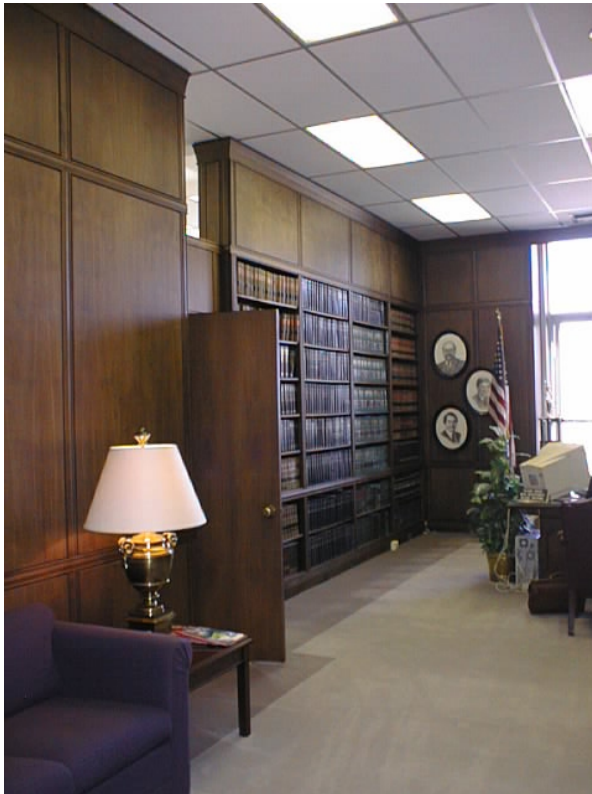
236

Notes elements will be the same as the Attorney General's office - check those listings.

Element	Description	Historical Significance	Notes
SP-3	Wood bookcase, built-in	Contributory Qty:	
D-32	Metal wood-grained casing with metal louvered panels. Bankers glass transom	Very Significant Qty:	
WN-1	Aluminum replacement window	Non Contributory Qty:	
W-7	Plaster wall, painted and smooth	Contributory Qty:	
W-18	demountable wall	Non Contributory Qty:	Wood paneled
D-15	Wood slab door with plain wood casing (simple closet/demountable doors)	Contributory Qty:	
F-12	Carpeted floor, glue-down	Contributory Qty:	
L-08	Fluorescent lights	Non Contributory Qty:	
CL-08	Acoustical ceiling, suspended T-bar frame	Non-Contributory Qty:

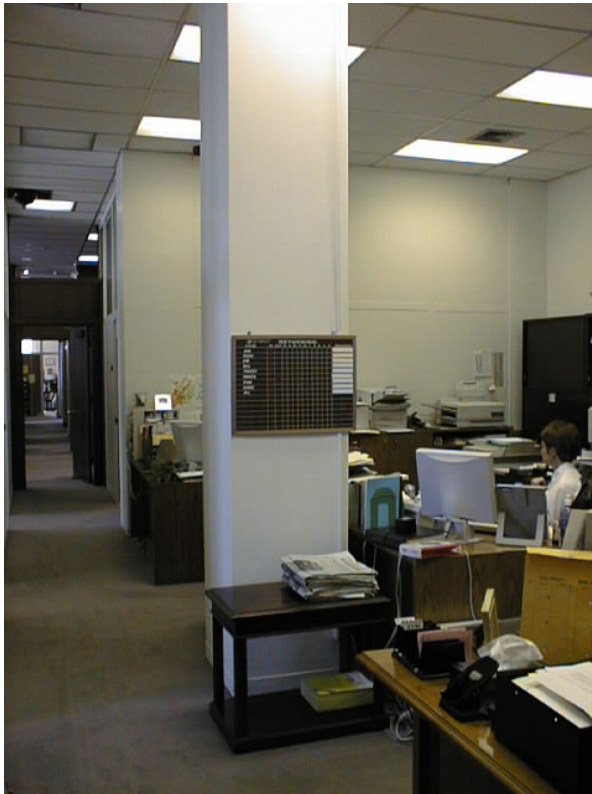
237

Element	Description	Historical Significance	Notes
CL-08	Acoustical ceiling, suspended T-bar frame	Non-Contributory Qty:	
CPP-7	Plaster pilaster, painted	Significant Qty:	
D-15	Wood slab door with plain wood casing (simple closet/demountable doors)	Contributory Qty:	Check door - part of wood paneled wall - entry doors to A.G. office and general space.
F-11	Carpeted floor, on pad	Contributory Qty:	
L-08	Fluorescent lights	Non Contributory Qty:	
M-6	Metal wood-grained casing w/ fancy profile	Non-Contributory Qty:	
W-13	Wallpapered wall, bookcloth/burlap	Contributory Qty:	
W-18	demountable wall	Non Contributory Qty:	painted
W-7	Plaster wall, painted and smooth	Contributory Qty:

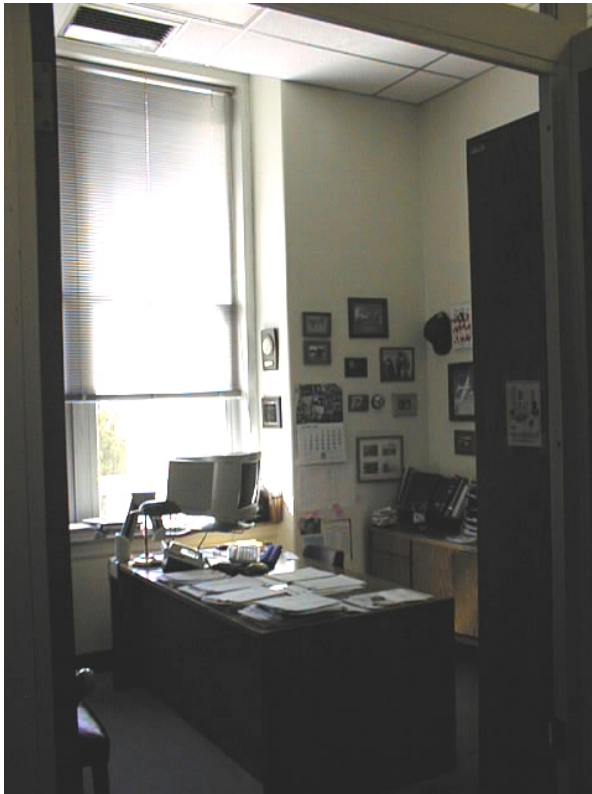
237a Attorney General Offices

Notes Includes 237 B & C,D

Element	Description	Historical Significance	Notes
CL-08	Acoustical ceiling, suspended T-bar frame	Non-Contributory Qty:	
WN-9	Leaded glass window, interior	Significant Qty:	specific to 237D & 220K
CPP-7	Plaster pilaster, painted	Significant Qty:	
B-6	Plaster base, painted	Contributory Qty:	
D-15	Wood slab door with plain wood casing (simple closet/demountable doors)	Contributory Qty:	
F-11	Carpeted floor, on pad	Contributory Qty:	
L-08	Fluorescent lights	Non Contributory Qty:	
W-18	demountable wall	Non Contributory Qty:	painted white
W-7	Plaster wall, painted and smooth	Contributory Qty:	
WN-1	Aluminum replacement window	Non Contributory Qty:	
WN-11	Metal transom, louvered	Non-Contributory Qty:	
D-25	Wood panel door with decorative wood casing	Contributory Qty:	Part of wood panel wall

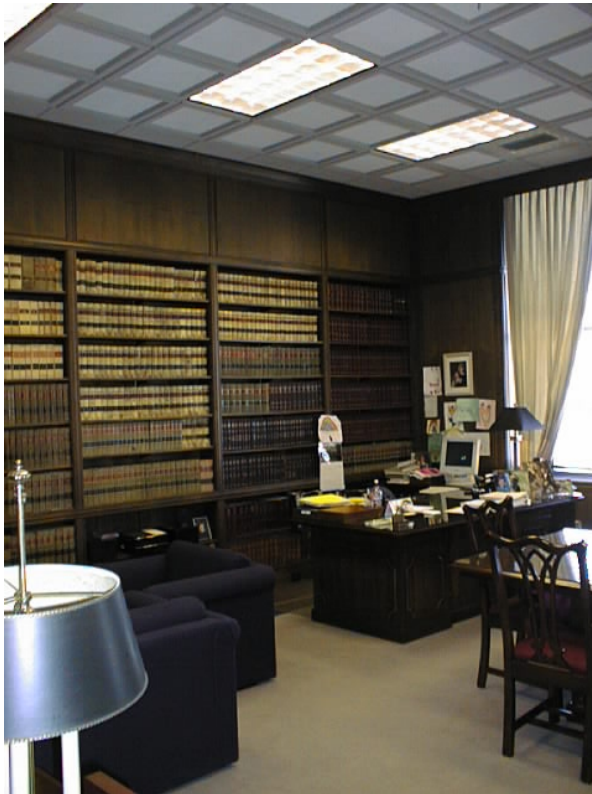
239 Attorney General's Office

Notes Mostly new- wood paneled walls - very basic.

Element	Description	Historical Significance	Notes
SP-3	Wood bookcase, built-in	Contributory Qty:	
CL-08	Acoustical ceiling, suspended T-bar frame	Non-Contributory Qty:	Decorative/ coffered look.
D-15	Wood slab door with plain wood casing (simple closet/demountable doors)	Non-Contributory Qty:	
F-12	Carpeted floor, glue-down	Contributory Qty:	custom boardering - multi- tone carpet boarder
L-81	Parabolic	Non-Contributory Qty:	
W-4	Wood panelled wall	Non Contributory Qty:	Wood panneling along all walls - includes wood base - non decrative
WN-1	Aluminum replacement window	Non Contributory Qty: 2

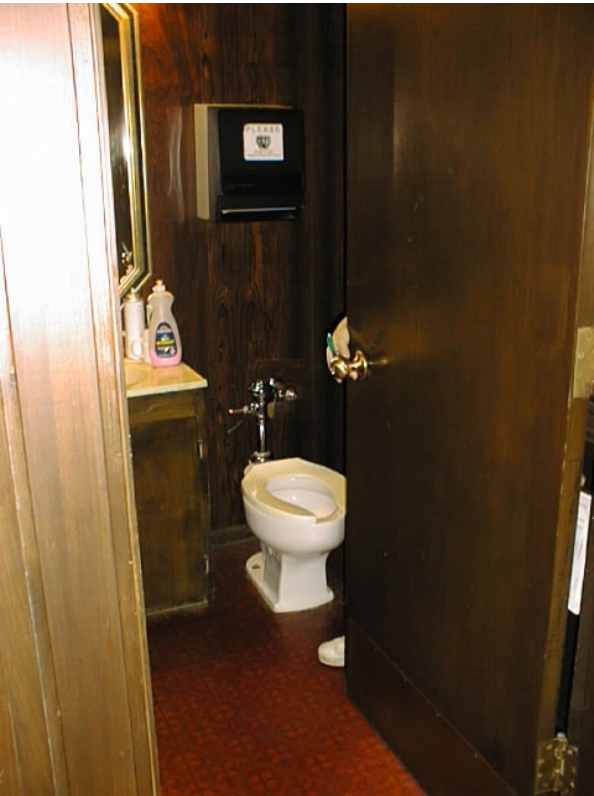
239a

small restroom -also bi-fold doors to a small closet within.
 The ceiling is foam acoustic - drop ceiling - need number for that!

Element	Description	Historical Significance	Notes
B-2	Molded wood base	Contributory Qty:	no decoration - part of wood paneling for the walls
D-15	Wood slab door with plain wood casing (simple closet/demountable doors)	Contributory Qty:	
F-9	Linoleum floor	Non-Contributory Qty:	
P-10	Toilet, Non-original	Non-Contributory Qty:	
P-6	Metal sink	Non-Contributory Qty:	
W-4	Wood panelled wall	Non Contributory Qty:

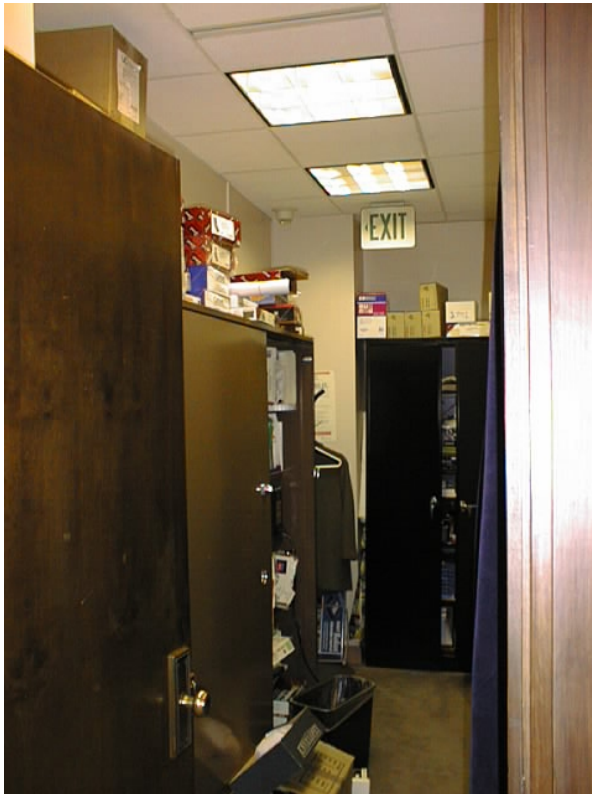
Attorney General Storage area

Element	Description	Historical Significance	Notes
B-6	Plaster base, painted	Contributory Qty:	
CL-08	Acoustical ceiling, suspended T-bar frame	Non-Contributory Qty:	
D-13	Metal wood-grained panel door with matching casing. Bankers glass panels	Contributory Qty:	
F-11	Carpeted floor, on pad	Contributory Qty:	
L-81	Parabolic	Non-Contributory Qty:	
D-23	Wood slab door with decorative wood casing	Contributory Qty:	painted

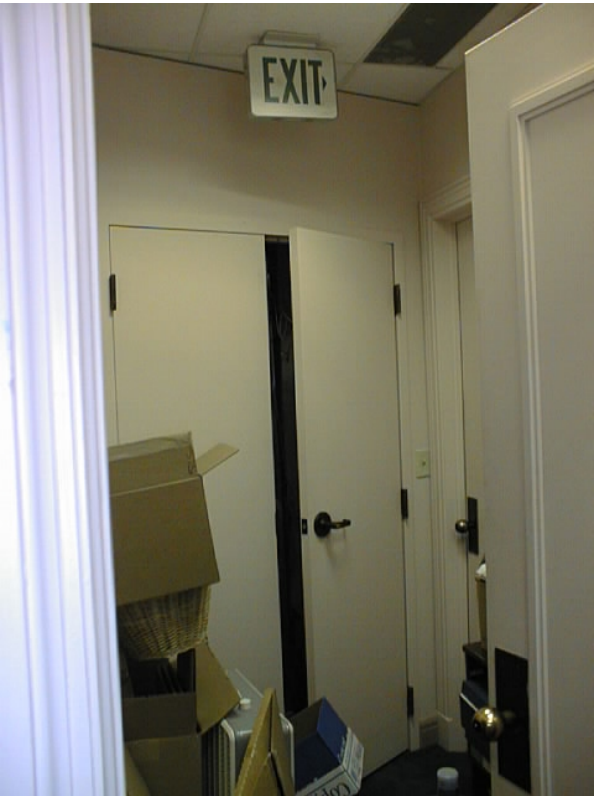
239c

Element	Description	Historical Significance	Notes
B-6	Plaster base, painted	Contributory Qty:	
CL-08	Acoustical ceiling, suspended T-bar frame	Non-Contributory Qty:	
D-13	Metal wood-grained panel door with matching casing. Bankers glass panels	Contributory Qty:	
D-15	Wood slab door with plain wood casing (simple closet/demountable doors)	Non Contributory Qty:	Storage/Hub closet
F-11	Carpeted floor, on pad	Contributory Qty:	
L-08	Fluorescent lights	Non Contributory Qty:	
D-25	Wood panel door with decorative wood casing	Non Contributory Qty:

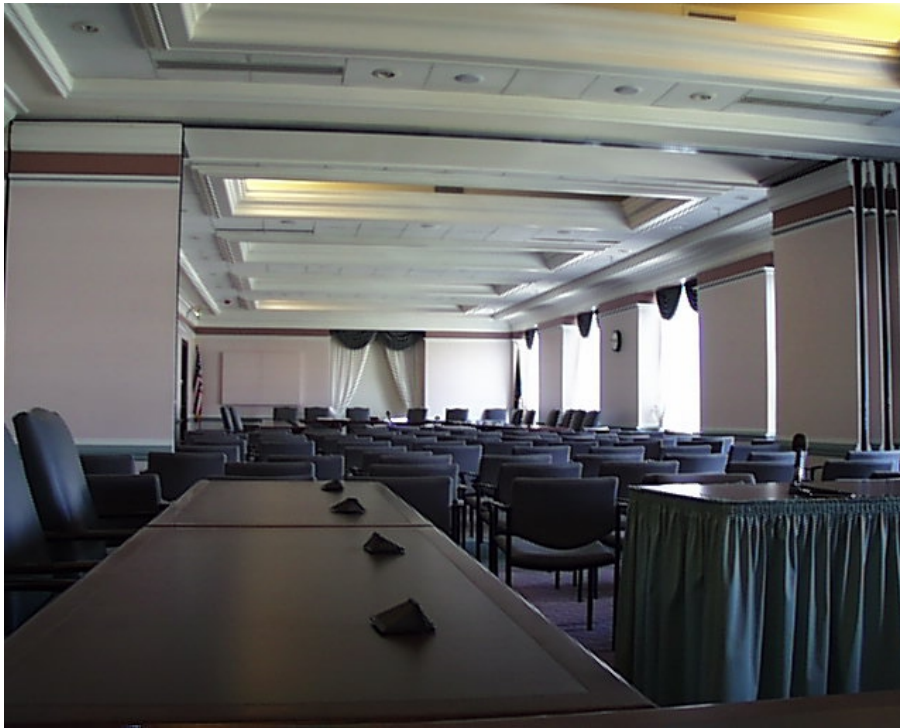
303 Committee Room

Notes Includes 305

Element	Description	Historical Significance	Notes
D-25	Wood panel door with decorative wood casing	Contributory Qty:	
F-11	Carpeted floor, on pad	Contributory Qty:	
CL-06	Sheetrock ceiling, painted	Non Contributory Qty:	
D-07	Wood Panel door with decorative metal wood-grained casing	Contributory Qty:	
W-8	Sheetrock wall, painted and smooth	Contributory Qty:	
W-7	Plaster wall, painted and smooth	Contributory Qty:	
W-24	Accordian dividing wall, painted and molded as wall	Non Contributory Qty:	
M-20	light cove	Non Contributory Qty:	
WN-1	Aluminum replacement window	Contributory Qty:	
M-12	Wood picture rail	Non Contributory Qty:	
M-11	Wood chair rail	Non Contributory Qty:	
B-2	Molded wood base	Contributory Qty:	4"
CL-08	Acoustical ceiling, suspended T-bar frame	Non-Contributory Qty:	
CR-2	Plaster cornice: crown molding, classical and simple	Contributory Qty:	
L-14	Recessed lights	Non-Contributory Qty:

L-12	Indirect cove lighting	Non-Contributory Qty:
L-81	Parabolic	Non-Contributory Qty:
WN-1	Aluminum replacement window	Non-Contributory Qty:

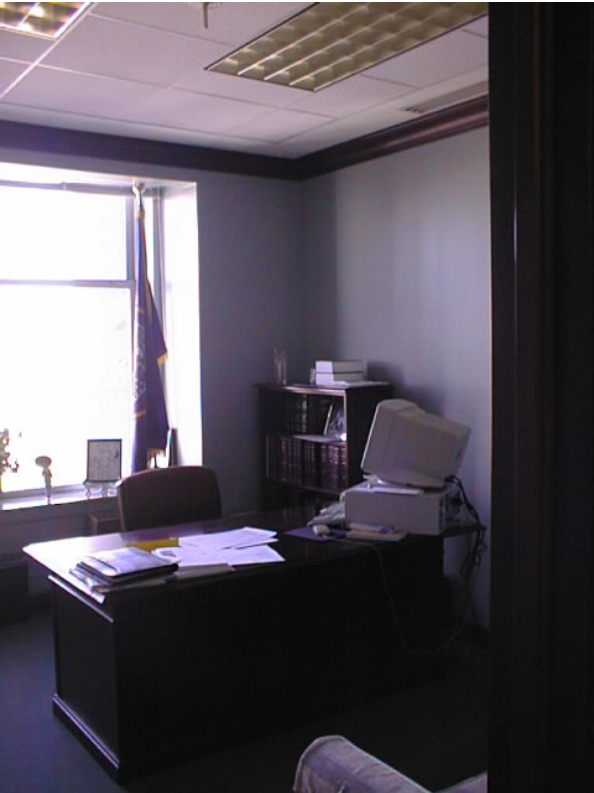
304
Office

Element	Description	Historical Significance	Notes
W-7	Plaster wall, painted and smooth	Contributory Qty:	
WN-1	Aluminum replacement window	Non-Contributory Qty:	
L-81	Parabolic	Non-Contributory Qty:	
CR-5	Wood cornice	Contributory Qty:	
M-11	Wood chair rail	Non-Contributory Qty:	
CL-08	Acoustical ceiling, suspended T-bar frame	Non-Contributory Qty:	
B-2	Molded wood base	Contributory Qty:

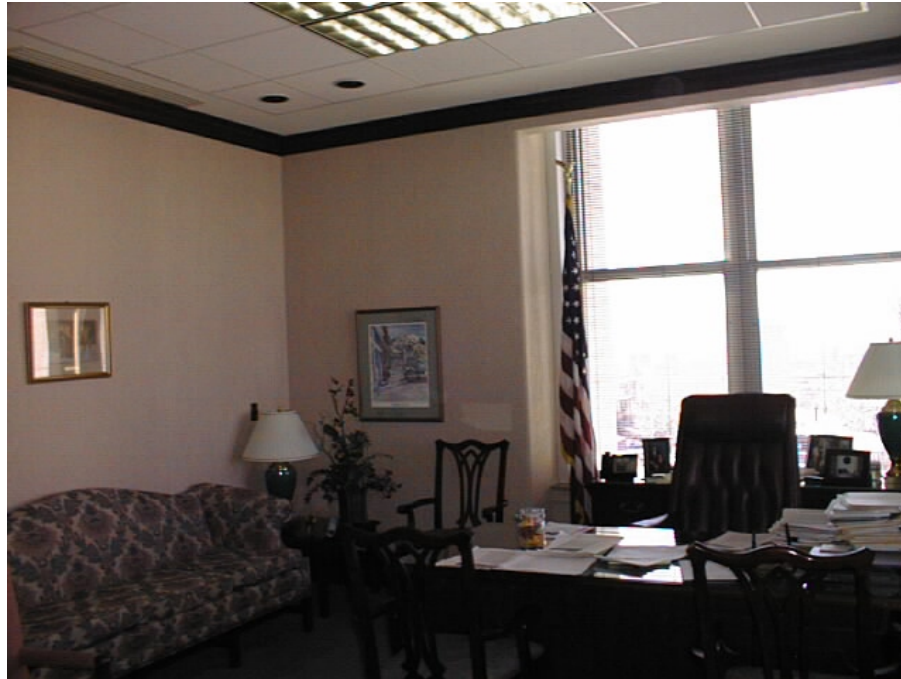
Notes includes rooms, 307,308,310,312,317,321

Element	Description	Historical Significance	Notes
B-2	Molded wood base	Contributory Qty:	10"
CL-06	Sheetrock ceiling, painted	Non-Contributory Qty:	
CL-08	Acoustical ceiling, suspended T-bar frame	Non-Contributory Qty:	
CR-5	Wood cornice	Non-Contributory Qty:	
D-25	Wood panel door with decorative wood casing	Contributory Qty: 2	also - used as closet doors - 2' double doors - closet/storage
F-11	Carpeted floor, on pad	Contributory Qty:	
L-81	Parabolic	Non-Contributory Qty:	
M-16	Marble window sill, original, with molded wood skirt	Non-Contributory Qty:	
W-13	Wallpapered wall, bookcloth/burlap	Contributory Qty:	not in room 316
WN-1	Aluminum replacement window	Non-Contributory Qty: 2	
L-14	Recessed lights	Non Contributory Qty:	specific to room 307

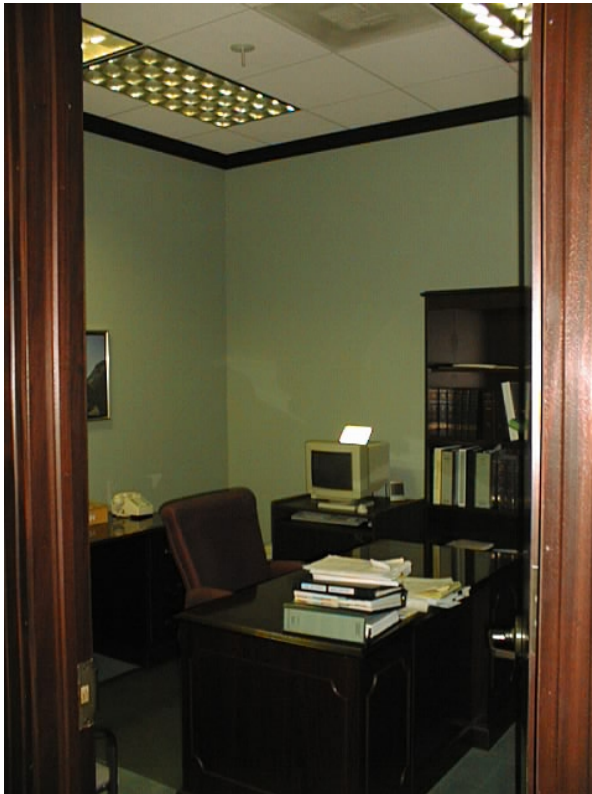
307a House Secretary Area

Notes includes room 318B, 313/314

Element	Description	Historical Significance	Notes
B-2	Molded wood base	Contributory Qty:	Stained
M-16	Marble window sill, original, with molded wood skirt	Contributory Qty:	
F-11	Carpeted floor, on pad	Contributory Qty:	
D-25	Wood panel door with decorative wood casing	Contributory Qty:	
CL-08	Acoustical ceiling, suspended T-bar frame	Contributory Qty:	
CR-5	Wood cornice	Contributory Qty:	
L-81	Parabolic	Non Contributory Qty:	
CL-06	Sheetrock ceiling, painted	Non Contributory Qty:	
L-14	Recessed lights	Non Contributory Qty:	
W-8	Sheetrock wall, painted and smooth	Contributory Qty:	
WN-3	Interior transom	Non Contributory Qty:	specific to room 313 and 314

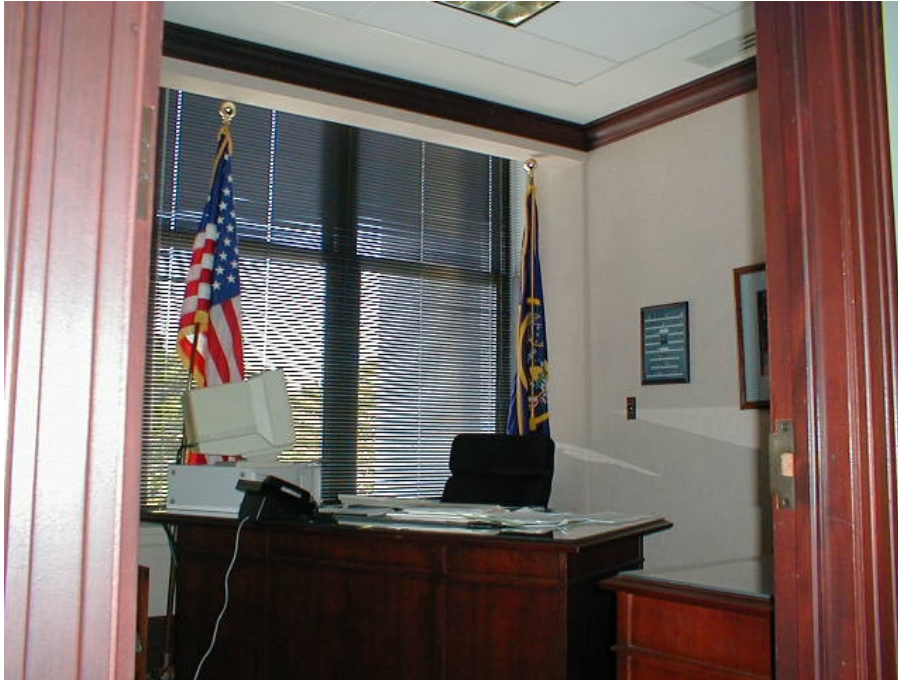
308 Majority Leader

Notes Includes rooms 310, 312- 314, 316, 317& 321

Element	Description	Historical Significance	Notes
B-2	Molded wood base	Contributory Qty:	10"
CL-06	Sheetrock ceiling, painted	Non-Contributory Qty:	at perimeter
CL-08	Acoustical ceiling, suspended T-bar frame	Non-Contributory Qty:	
CR-5	Wood cornice	Non-Contributory Qty:	
D-11	Metal wood-grained panel door with matching casing. Plain louver transom	Contributory Qty:	
F-11	Carpeted floor, on pad	Contributory Qty:	
L-81	Parabolic	Non-Contributory Qty:	
M-16	Marble window sill, original, with molded wood skirt	Non-Contributory Qty:	
M-19	Wood casing, new	Non-Contributory Qty:	
W-13	Wallpapered wall, bookcloth/burlap	Contributory Qty:	
WN-1	Aluminum replacement window	Non-Contributory Qty:

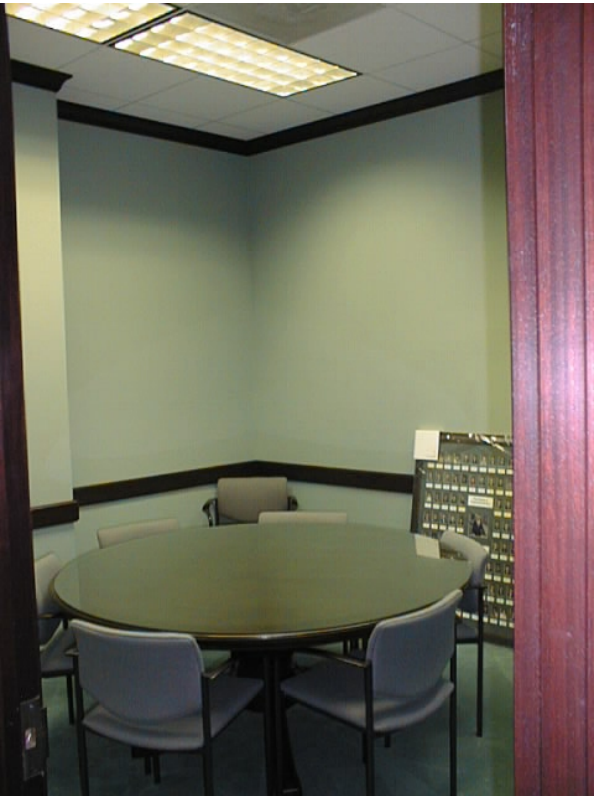
309

Notes includes room 311, 315

Element	Description	Historical Significance	Notes
B-2	Molded wood base	Contributory Qty:	small scale, stained
Cr-5	Wood cornice	Contributory Qty:	small scale
CL-08	Acoustical ceiling, suspended T-bar frame	Contributory Qty:	
L-81	Parabolic	Non Contributory Qty:	
F-11	Carpeted floor, on pad	Contributory Qty:	
D-15	Wood slab door with plain wood casing (simple closet/demountable doors)	Non Contributory Qty:	
M-11	Wood chair rail	Non Contributory Qty:	room 311 only

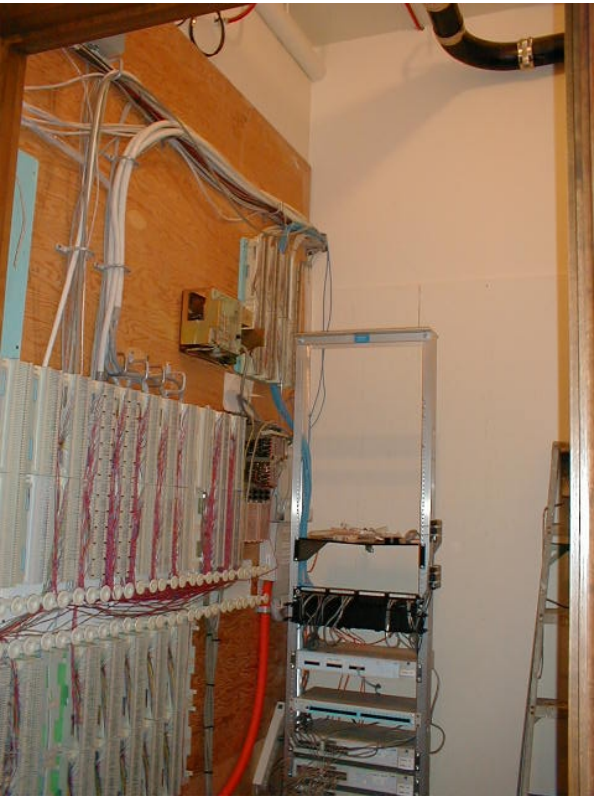
319a Senate Circuit Room

Includes 319 b

Element	Description	Historical Significance	Notes
B-12	Carpet base	Non Contributory Qty:	
CL-04	Plaster ceiling, smooth, flat, painted	Non Contributory Qty:	
CR-2	Plaster cornice: crown molding, classical and simple	Contributory Qty:	on south wall
D-13	Metal wood-grained panel door with matching casing. Bankers glass panels	Contributory Qty: 1	with M-19, M-41
F-12	Carpeted floor, glue-down	Contributory Qty:	
L-28	Rotunda Chandelier	Non Contributory Qty:

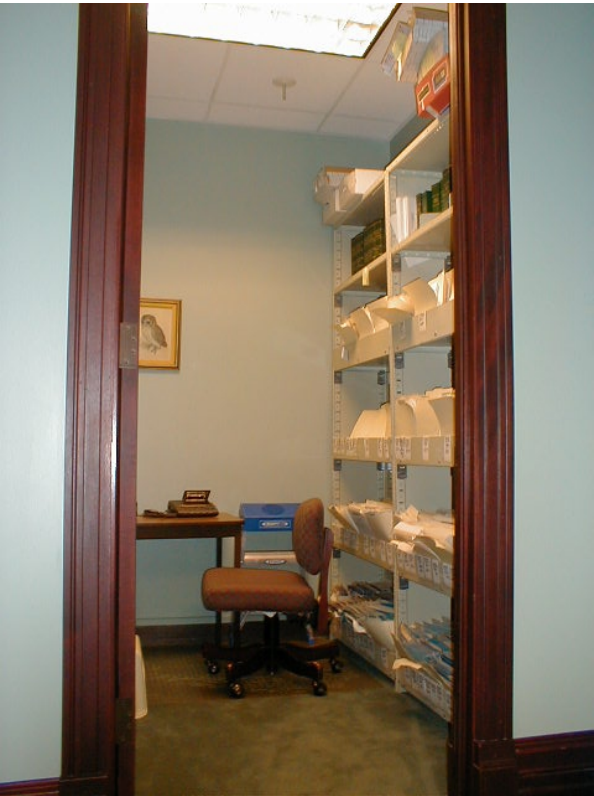
320b

Element	Description	Historical Significance	Notes
B-6	Plaster base, painted	Contributory Qty:	
CL-08	Acoustical ceiling, suspended T-bar frame	Non-Contributory Qty:	
D-25	Wood panel door with decorative wood casing	Contributory Qty:	
F-11	Carpeted floor, on pad	Contributory Qty:	
L-81	Parabolic	Non Contributory Qty:	
B-4	Rubber/vinyl base	Contributory Qty:

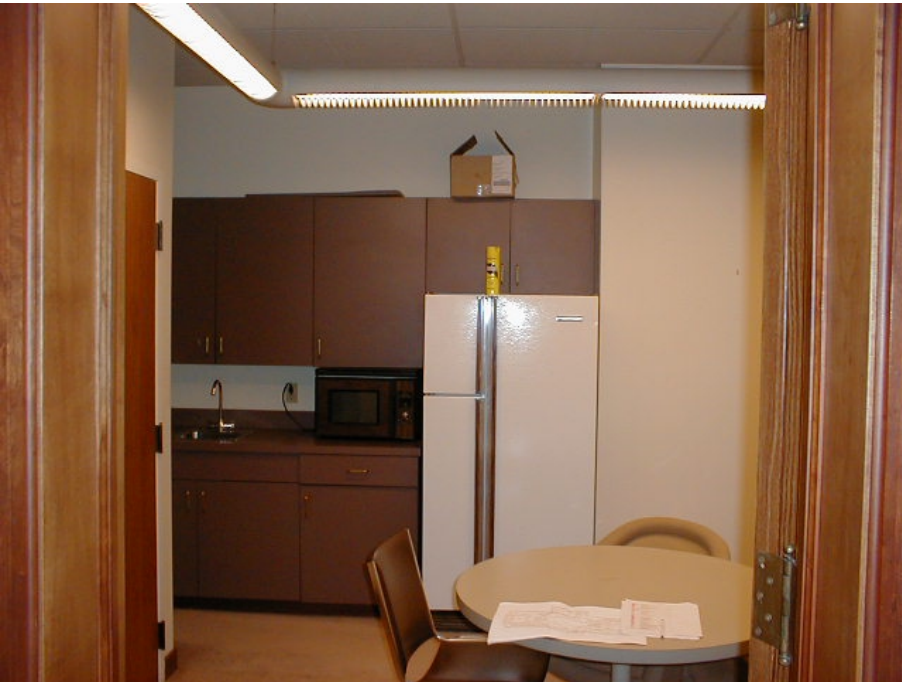
331b

Element	Description	Historical Significance	Notes
SP-3	Wood bookcase, built-in	Non Contributory Qty:	Laminate
E-12	electrical box	Contributory Qty:	Various
B-2	Molded wood base	Contributory Qty:	Stain
W-7	Plaster wall, painted and smooth	Significant Qty:	
W-8	Sheetrock wall, painted and smooth	Contributory Qty:	
D-11	Metal wood-grained panel door with matching casing. Plain louver transom	Significant Qty:	East
F-12	Carpeted floor, glue-down	Contributory Qty:	
CL-08	Acoustical ceiling, suspended T-bar frame	Non-Contributory Qty:	
L-82	Pendent Parabolic	Non Contributory Qty:	
D-03	Metal wood-grained panel door, wood bollection molding casing with bankers glass glazing panels and transom	Very Significant Qty:	double doors - storag closets (2 sets)
D-14	Metal wood-grained panel door with decorative wood casing. Bankers glass panels	Significant Qty:	South

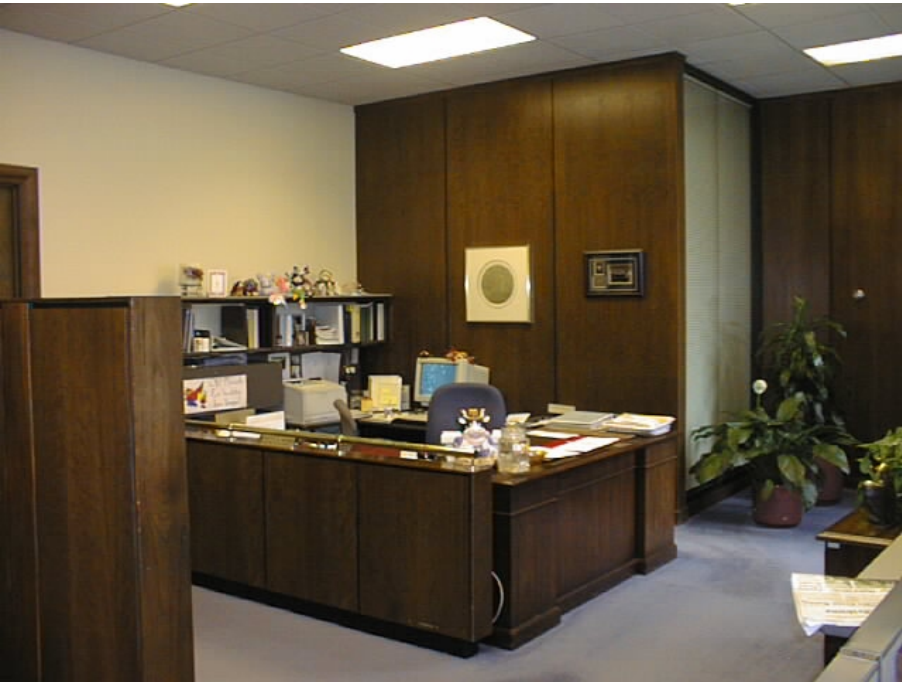
361

Notes office areas are furnished with systems furniture

Element	Description	Historical Significance	Notes
W-4	Wood panelled wall	Contributory Qty:	North wall - Presidents reception area
B-12	Carpet base	Non Contributory Qty:	Around columns
B-12	Carpet base	Non Contributory Qty:	on columns
B-2	Molded wood base	Contributory Qty:	Stain
CL-08	Acoustical ceiling, suspended T-bar frame	Non Contributory Qty:	
F-12	Carpeted floor, glue-down	Contributory Qty:	
L-08	Fluorescent lights	Non Contributory Qty:	
W-8	Sheetrock wall, painted and smooth	Contributory Qty:	
WN-1	Aluminum replacement window	Non Contributory Qty:	with M-16

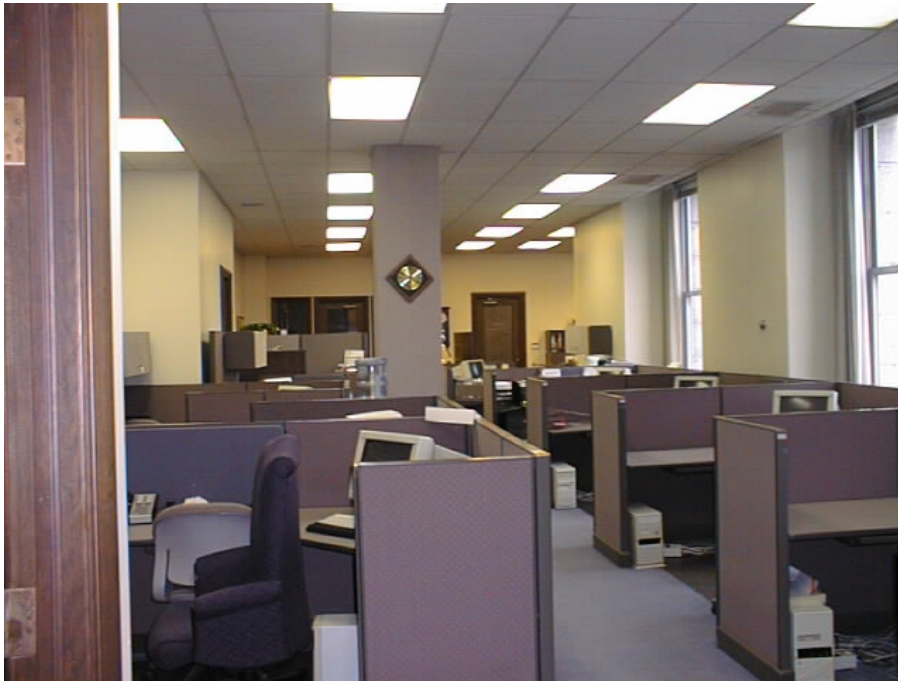
361 Senate Business Office

Notes office areas are furnished with systems furniture

Element	Description	Historical Significance	Notes
W-4	Wood panelled wall	Contributory Qty:	North wall - Presidents reception area
B-12	Carpet base	Non Contributory Qty:	Around columns
B-12	Carpet base	Non Contributory Qty:	on columns
B-2	Molded wood base	Contributory Qty:	Stain
CL-08	Acoustical ceiling, suspended T-bar frame	Non Contributory Qty:	
F-12	Carpeted floor, glue-down	Contributory Qty:	
L-08	Fluorescent lights	Non Contributory Qty:	
W-8	Sheetrock wall, painted and smooth	Contributory Qty:	
WN-1	Aluminum replacement window	Non Contributory Qty:	with M-16

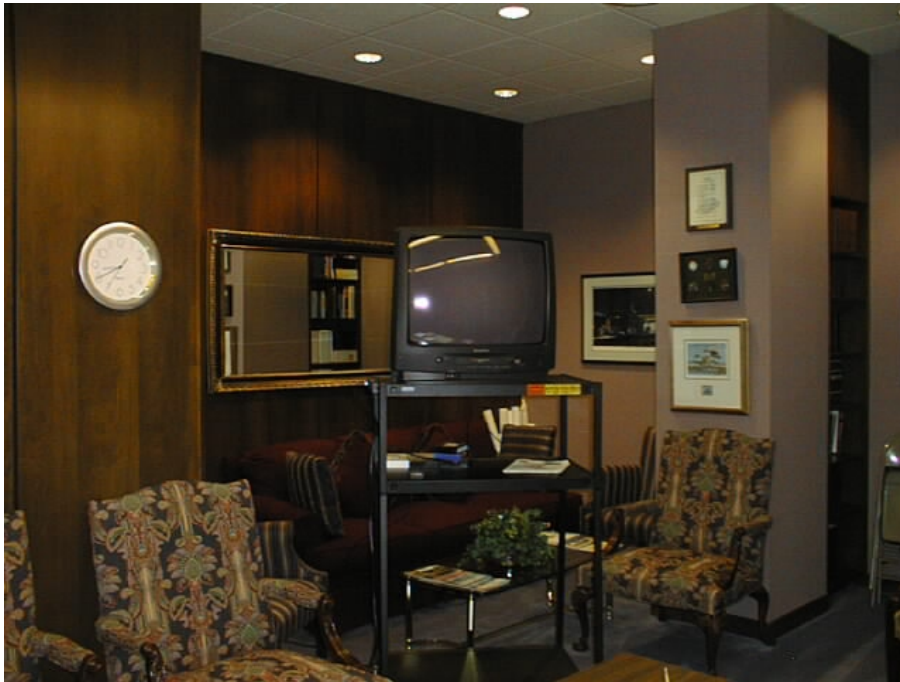
366 Senate President

Element	Description	Historical Significance	Notes
B-2	Molded wood base	Contributory Qty:	Stained
CL-08	Acoustical ceiling, suspended T-bar frame	Non Contributory Qty:	
D-14	Metal wood-grained panel door with decorative wood casing. Bankers glass panels	Contributory Qty: 1	with M-6, B-7, H-3 to 317B, with no glass panel
D-02	Wood panel door, wood bollection molding casing	Contributory Qty: 1	with M-19, B-7, to hall
F-12	Carpeted floor, glue-down	Contributory Qty:	
HC-7	Duct	Non Contributory Qty:	above south door.
L-14	Recessed lights	Non Contributory Qty:	above seating area
L-08	Fluorescent lights	Non Contributory Qty:	Drop fluorescent
W-11	Fabric wall, glue-on	Contributory Qty:	
W-4	Wood panelled wall	Non Contributory Qty:	South
WN-1	Aluminum replacement window	Non Contributory Qty: 1 pr	with M-16

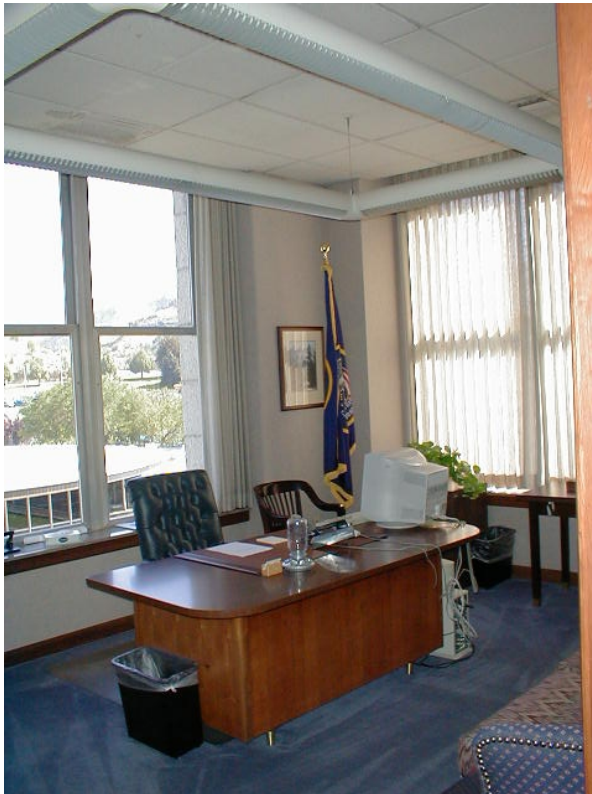
367 Senate Majority leader

Element	Description	Historical Significance	Notes
HC-7	Duct	Qnty:	above door - metal louvers
B-2	Molded wood base	Contributory Qnty:	Stain.
CL-08	Acoustical ceiling, suspended T-bar frame	Non Contributory Qnty:	
D-14	Metal wood-grained panel door with decorative wood casing. Bankers glass panels	Contributory Qnty: 1	with M-42, B-7, H-3 to hall, marble threshold
D-02	Wood panel door, wood bollection molding casing	Contributory Qnty: 1	with M-42, B-7 to 317A, to 366
F-12	Carpeted floor, glue-down	Contributory Qnty:	
L-82	Pendent Parabolic	Non Contributory Qnty:	drop parabolic
W-11	Fabric wall, glue-on	Contributory Qnty:	
W-8	Sheetrock wall, painted and smooth	Contributory Qnty:	
WN-1	Aluminum replacement window	Non Contributory Qnty: 2 pr	with M-16

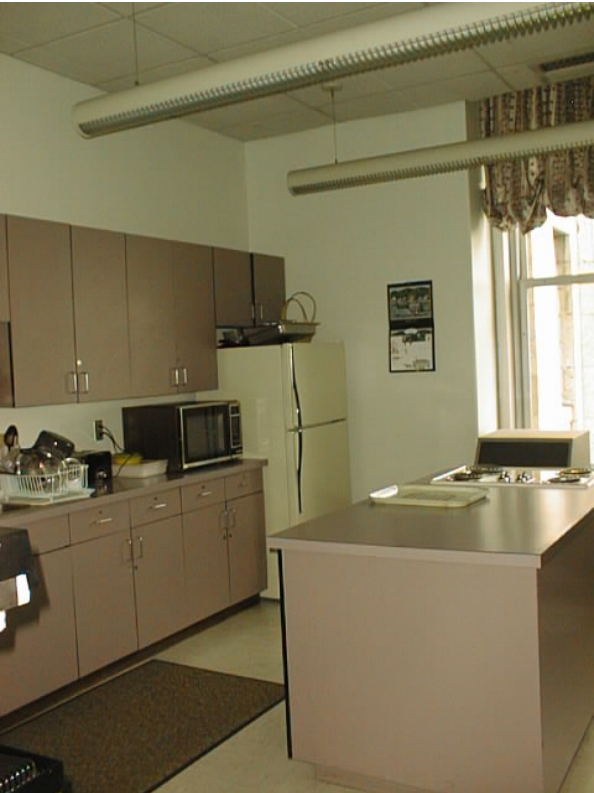
370d
Senate Kitchen

Element	Description	Historical Significance	Notes
D-14	Metal wood-grained panel door with decorative wood casing. Bankers glass panels	Significant Qty:	
SP-3	Wood bookcase, built-in	Non Contributory Qty:	
B-2	Molded wood base	Contributory Qty:	Stained
CL-08	Acoustical ceiling, suspended T-bar frame	Non Contributory Qty:	
D-09	Wood slab door with decorative metal-wood grained casing, transom above	Contributory Qty: 1	with M-42, B-7, H-3 to hall
F-10	Vinyl floor	Non Contributory Qty:	12" tiles
L-82	Pendent Parabolic	Non Contributory Qty:	
W-8	Sheetrock wall, painted and smooth	Contributory Qty:	
WN-1	Aluminum replacement window	Non Contributory Qty: 1 pr	with M-16

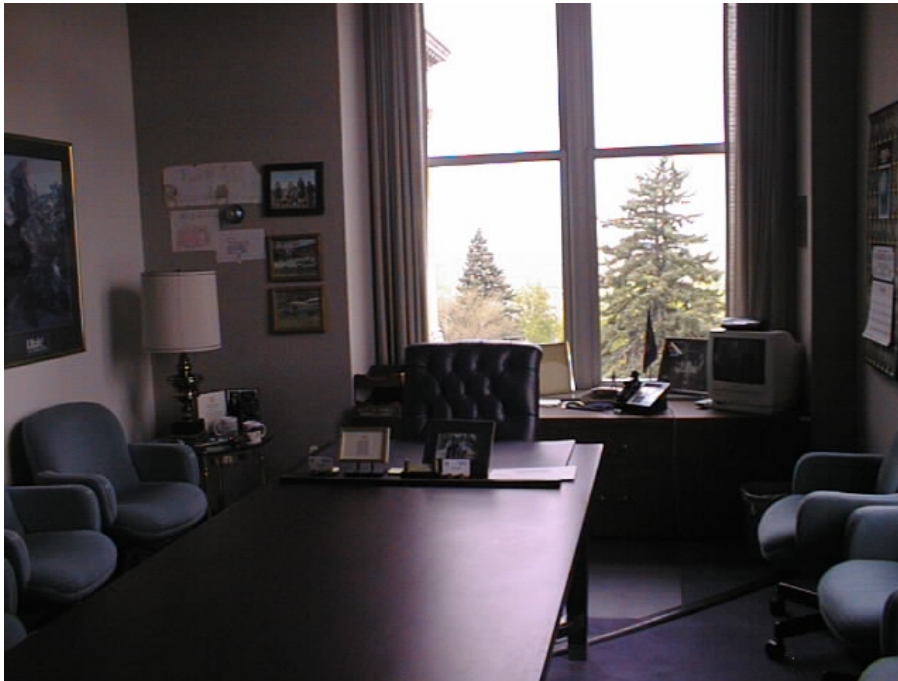
372

Element	Description	Historical Significance	Notes
CL-08	Acoustical ceiling, suspended T-bar frame	Non Contributory Qty:	
D-14	Metal wood-grained panel door with decorative wood casing. Bankers glass panels	Contributory Qty: 1	with M-42, B-7, H-1, to 311B
D-02	Wood panel door, wood bollection molding casing	Contributory Qty: 1	with M-42, B-7 from 311D
W-11	Fabric wall, glue-on	Contributory Qty:	
WN-1	Aluminum replacement window	Non Contributory Qty: 2 pr	with M-16
B-2	Molded wood base	Contributory Qty:	Stained
F-12	Carpeted floor, glue-down	Contributory Qty:	
L-08	Fluorescent lights	Non Contributory Qty:	
W-8	Sheetrock wall, painted and smooth	Contributory Qty:

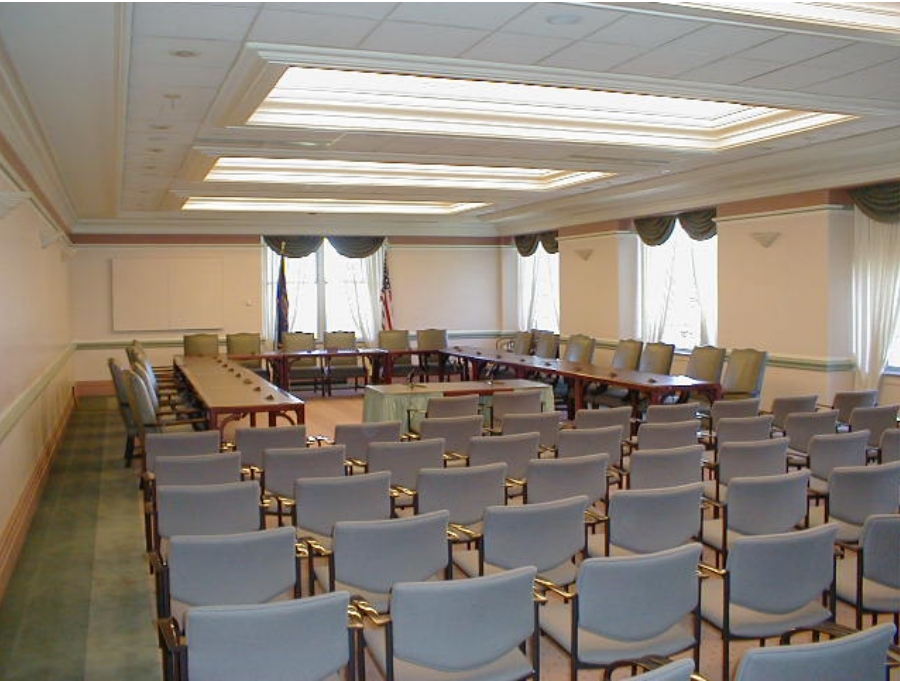
403 Committee Rooms

Notes Includes room 404,405

Element	Description	Historical Significance	Notes
W-8	Sheetrock wall, painted and smooth	Contributory Qty:	
D-07	Wood Panel door with decorative metal wood-grained casing	Contributory Qty:	Door at entrance to room
D-06	Metal wood grained panel door with frosted glass panels. Casing is decorative wood or metal wood grained.	Contributory Qty:	Placed at entrance to committee room vestibule, room 404
L-22	Wall sconce (new) frosted glass, cone-shaped	Qty: 20	
M-11	Wood chair rail	Contributory Qty:	
M-16	Marble window sill, original, with molded wood skirt	Contributory Qty:	
M-20	light cove	Non Contributory Qty:	
W-7	Plaster wall, painted and smooth	Contributory Qty:	
B-6	Plaster base, painted	Contributory Qty:	
CL-06	Sheetrock ceiling, painted	Non-Contributory Qty:	
CL-08	Acoustical ceiling, suspended T-bar frame	Non-Contributory Qty:	Central to room in separate pannels, surrounded by sheetrock ceiling.

CR-2	Plaster cornice: crown molding, classical and simple	Very Significant Qty:
D-07	Wood Panel door with decorative metal wood-grained casing	Contributory Qty:
F-11	Carpeted floor, on pad	Contributory Qty:
L-12	Indirect cove lighting	Contributory Qty:
L-14	Recessed lights	Non Contributory Qty:
L-22	Wall sconce (new) frosted glass, cone-shaped	Contributory Qty:
WN-1	Aluminum replacement window	Non Contributory Qty:

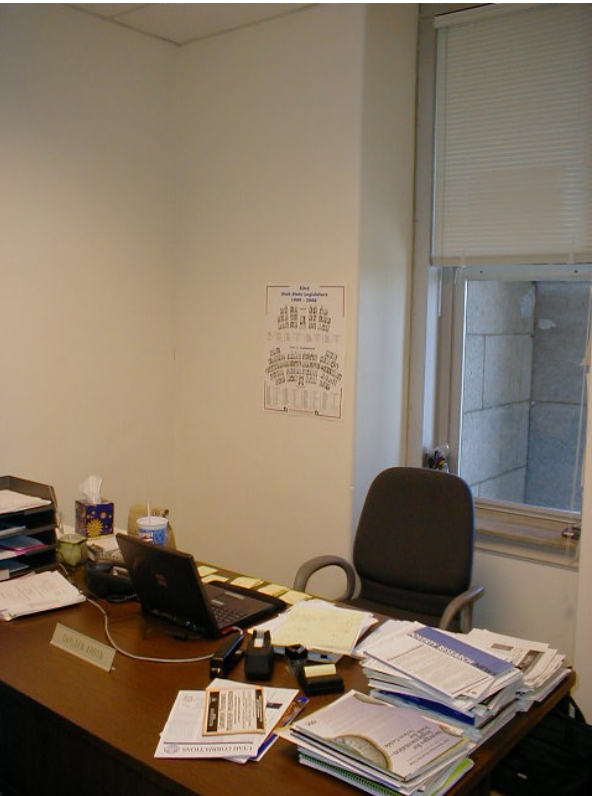
418

Element	Description	Historical Significance	Notes
B-6	Plaster base, painted	Contributory Qty:	painted plaster
CL-08	Acoustical ceiling, suspended T-bar frame	Non-Contributory Qty:	
D-04	Wood panel door, decorative metal wood-grained casing, transom above	Significant Qty:	
F-11	Carpeted floor, on pad	Contributory Qty:	
L-81	Parabolic	Non-Contributory Qty:	
W-7	Plaster wall, painted and smooth	Significant Qty:	
WN-1	Aluminum replacement window	Contributory Qty:	half size

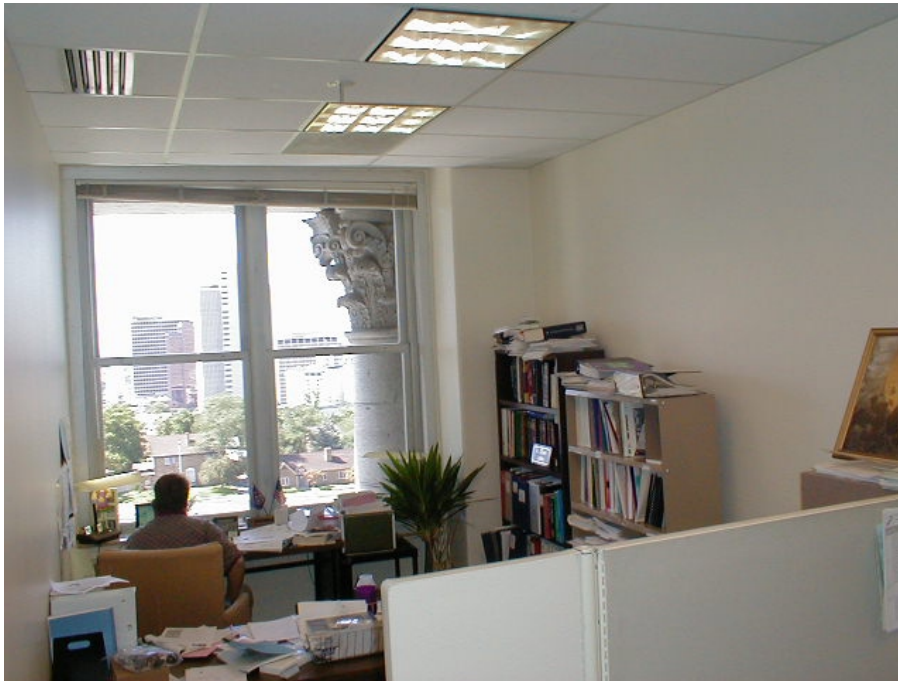
Notes Includes 421a -c 421 b was part of the art gallery - 421 a the light well.

Element	Description	Historical Significance	Notes
B-4	Rubber/vinyl base	Non-Contributory Qty:	bsae on the sheetrock wall - east side room 420
B-6	Plaster base, painted	Contributory Qty:	painted plaster
CL-08	Acoustical ceiling, suspended T-bar frame	Non-Contributory Qty:	
D-04	Wood panel door, decorative metal wood-grained casing, transom above	Contributory Qty:	
F-11	Carpeted floor, on pad	Contributory Qty:	
L-81	Parabolic	Non-Contributory Qty:	
W-7	Plaster wall, painted and smooth	Contributory Qty:	
W-8	Sheetrock wall, painted and smooth	Contributory Qty:	on east side of room 420
WN-1	Aluminum replacement window	Non Contributory Qty:	half size

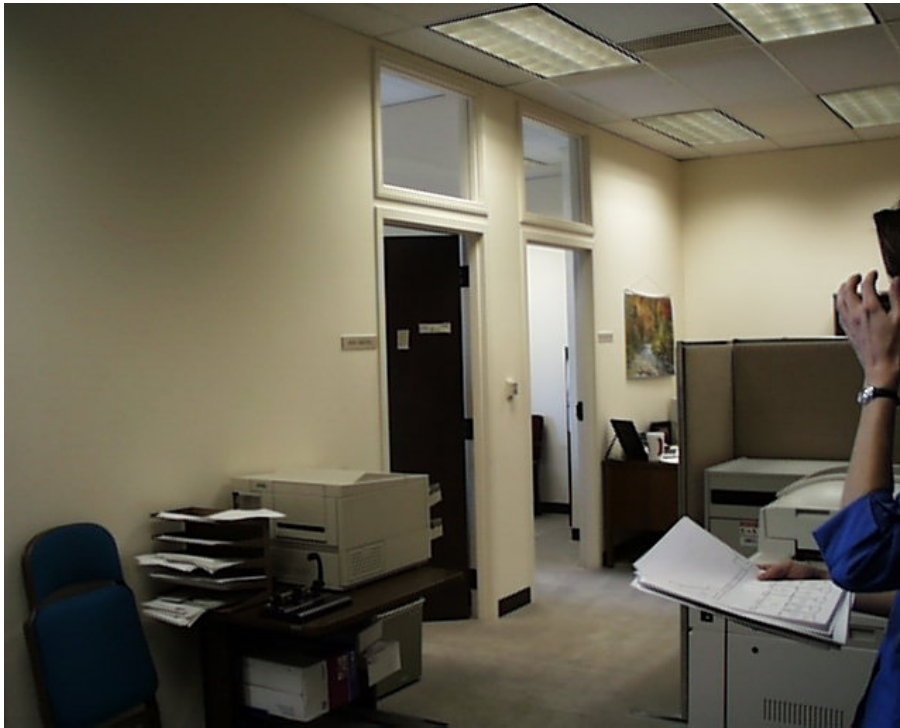
422 Office/ Legislative Research

Notes Includes 422a/b/c

Element	Description	Historical Significance	Notes
D-03	Metal wood-grained panel door, wood bollection molding casing with bankers glass glazing panels and transom	Non Contributory Qty:	
B-4	Rubber/vinyl base	Non-Contributory Qty:	bsae on the sheetrock wall - east side room 420
B-6	Plaster base, painted	Contributory Qty:	painted plaster
CL-08	Acoustical ceiling, suspended T-bar frame	Non-Contributory Qty:	
D-04	Wood panel door, decorative metal wood-grained casing, transom above	Contributory Qty:	
F-11	Carpeted floor, on pad	Contributory Qty:	
L-81	Parabolic	Non-Contributory Qty:	
W-7	Plaster wall, painted and smooth	Contributory Qty:	
W-8	Sheetrock wall, painted and smooth	Contributory Qty:	on east side of room 420
WN-1	Aluminum replacement window	Non Contributory Qty:	half size
WN-3	Interior transom	Contributory Qty:

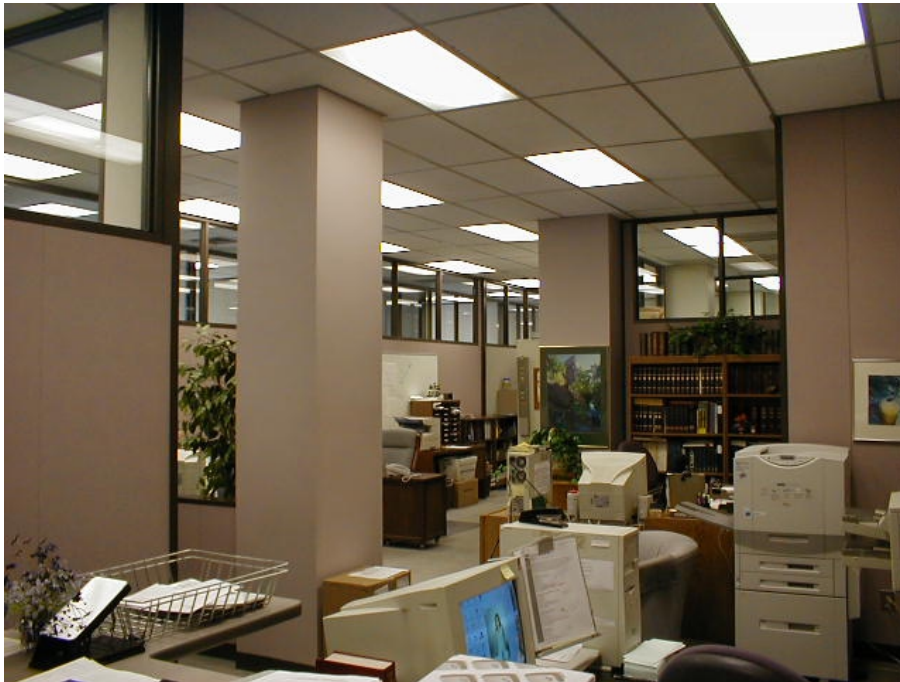
427 Fiscal Analyst

Notes Includes 428, 430, 431, 433 - 435, 437 - 441 & 443 - used to hold the art board room

Element	Description	Historical Significance	Notes
B-1	Gray marble base, 12" polished	Very Significant Qty:	
L-08	Fluorescent lights	Non Contributory Qty:	
D-10	Metal wood-grained panel door with matching casing. Bankers glass panel and transom	Contributory Qty:	
B-4	Rubber/vinyl base	Non-Contributory Qty:	
WN-4	Wood-grained, wire glass, awning-type transom	Contributory Qty:	
D-12	Metal wood-grained panel door with matching casing. Decorative louver transom	Qty:	
D-09	Wood slab door with decorative metal-wood grained casing, transom above	Contributory Qty:	
D-19	Wood slab door with plain metal casing. (demountable wall doors)	Qty:	
CPP-7	Plaster pilaster, painted	Significant Qty:	
CL-08	Acoustical ceiling, suspended T-bar frame	Non-Contributory Qty:	
M-6	Metal wood-grained casing w/ fancy profile	Non Contributory Qty:	
W-18	demountable wall	Non Contributory Qty:	
W-7	Plaster wall, painted and smooth	Very Significant Qty:

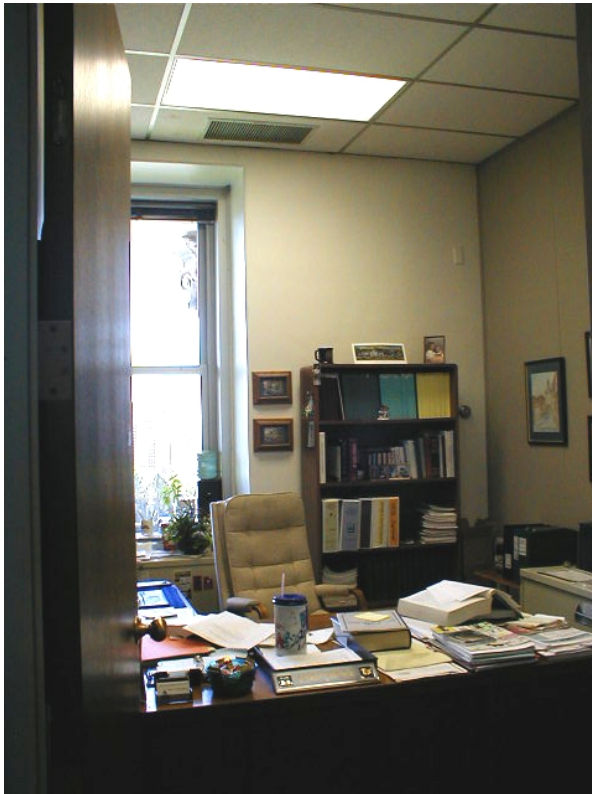
Notes Includes 445,447 thru 450-9,460-8 445 held state road commissioners

Element	Description	Historical Significance	Notes
B-1	Gray marble base, 12" polished	Very Significant Qty:	
B-4	Rubber/vinyl base	Non-Contributory Qty:	
B-6	Plaster base, painted	Contributory Qty:	
CL-08	Acoustical ceiling, suspended T-bar frame	Non-Contributory Qty:	
CPP-7	Plaster pilaster, painted	Significant Qty:	
D-09	Wood slab door with decorative metal-wood grained casing, transom above	Contributory Qty:	
F-14	Carpet tiles	Non-Contributory Qty:	
L-08	Fluorescent lights	Non Contributory Qty:	
M-6	Metal wood-grained casing w/ fancy profile	Non-Contributory Qty:	
W-18	demountable wall	Non Contributory Qty:	
WN-10	Transom grille, ornamental	Contributory Qty:	
WN-4	Wood-grained, wire glass, awning-type transom	Contributory Qty:
